# Holy Trinity Barn Church Kildoagh

**Holy Trinity, Barn Church, Kildoagh  
needs your help!  
Please!**

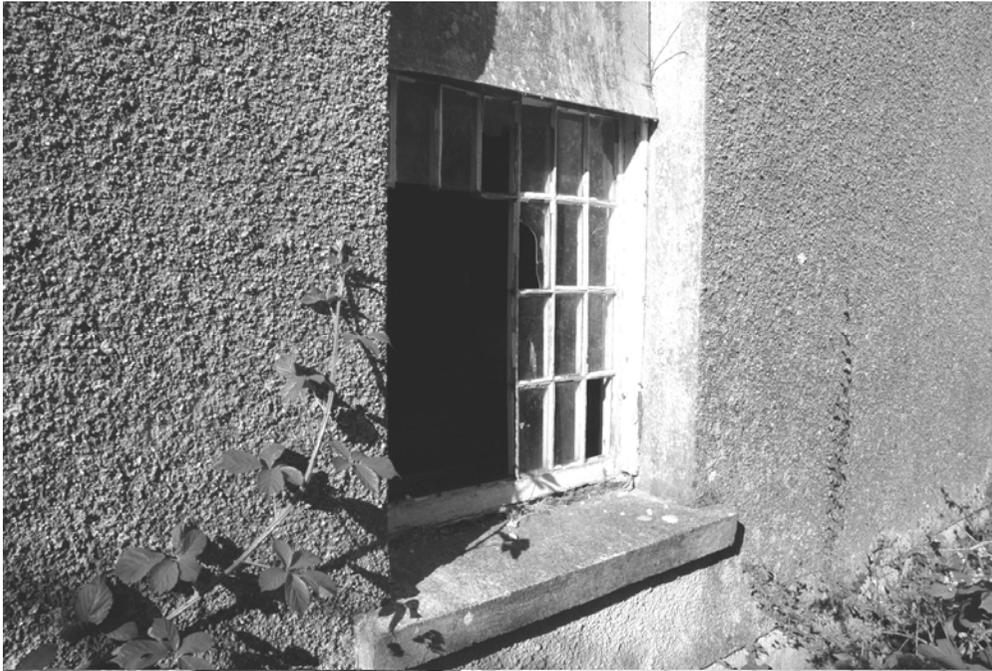
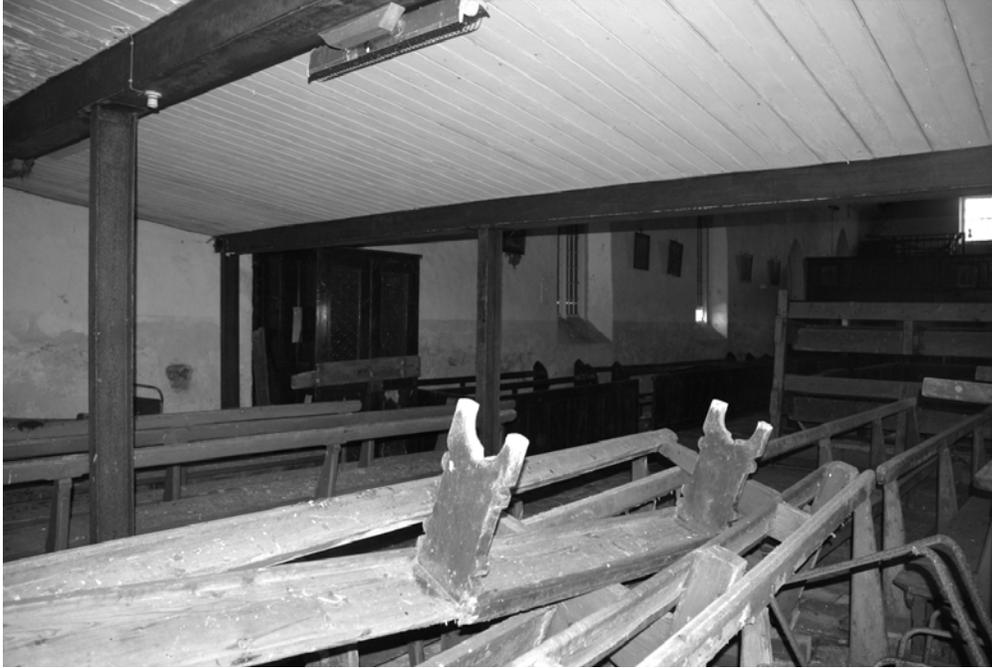
The top photo shows the open and completely unprotected window access to the interior of the church. The lower photo was taken through the open window

It is rapidly deteriorating through lack of simple and relatively cheap maintenance. A small amount of money spent now repairing the roof, boarding up the windows properly and protecting it from further vandalism would be a stitch in time and may save a lot more than nine!

We can spend a few hours replacing the broken slates and board up the windows properly.

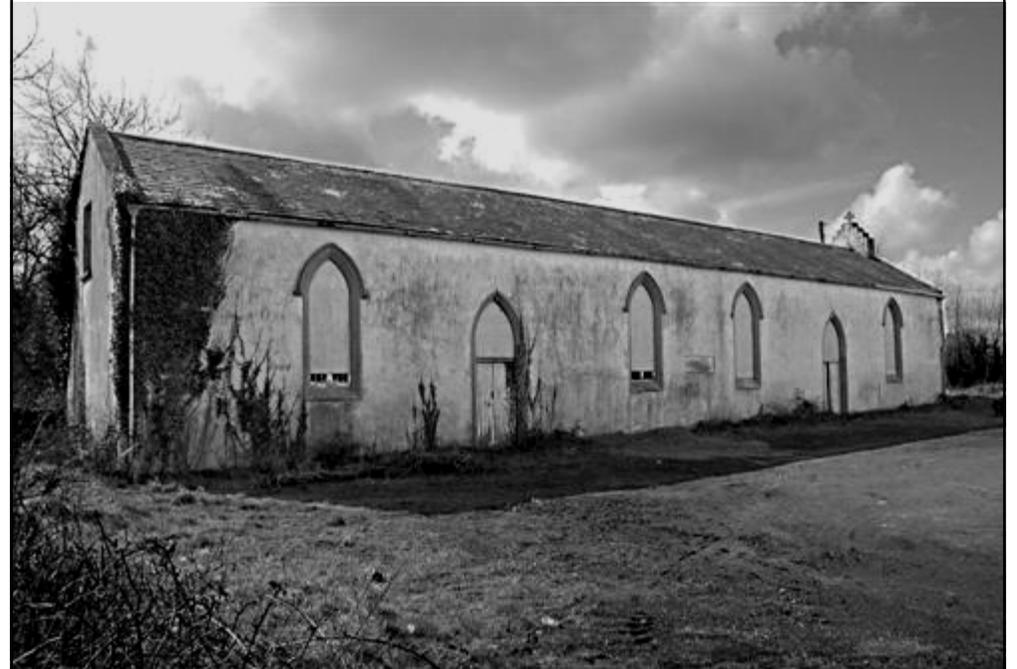
The photo on the front cover was taken in 2008. Note the ‘missing’ window in the photo above.

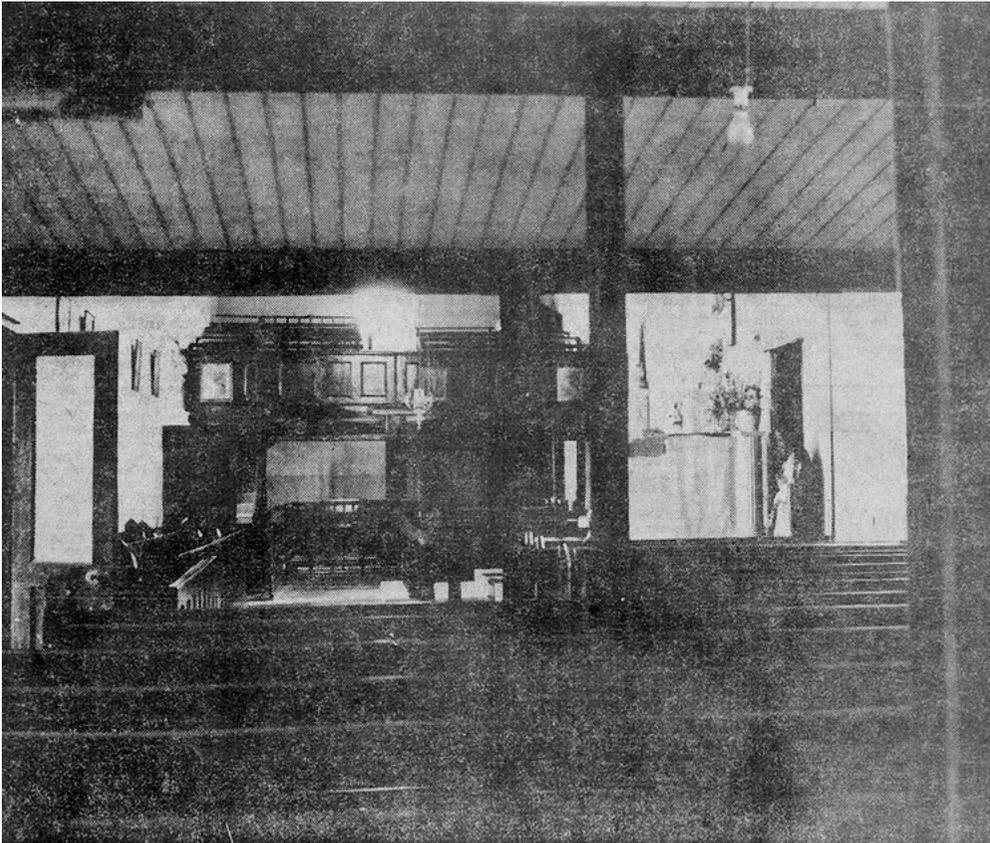
The photo at the top of this page is from one of the post Cards published and sold in McPartland’s shop in Bawnboy before the 1939 - 45 emergency but still available in the 1950s.
