# Holy Trinity Barn Church Kildoagh

**Holy Trinity, Barn Church, Kildoagh  
needs your help!  
Please!**

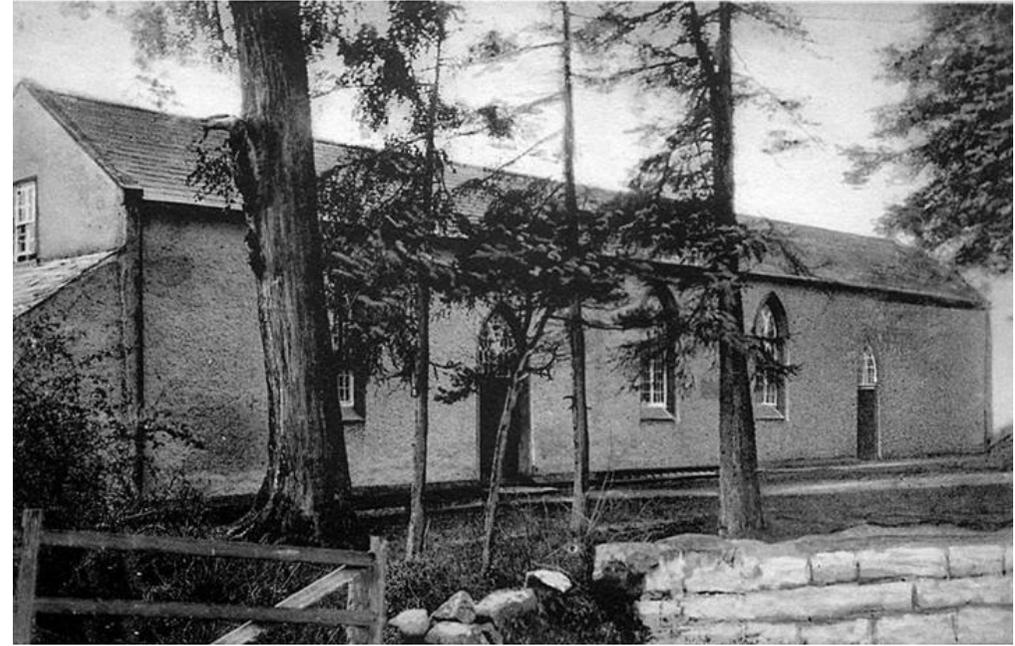
This article and the photograph on page 2 have been taken from the Irish Times dated Tuesday 2nd December 1975. The photo is credited to William Garner & An Fóras Forbartha.

The photo on the front cover was taken in 2008. Note the ‘missing’ window in the photo above.

We can spend a few hours replacing the broken slates and board up the windows properly.
